## Survey Report On

**5 Main Street,  
Kirkwall,  
Orkney,  
KW15 1BU.**

**Client:** Mr James Currie and Mrs Isobel Currie.  
**Client address:** 5 Main Street, Kirkwall, Orkney, KW15 1BU.  
**Date of inspection:** 22<sup>nd</sup> August 2023.  
**Prepared by:** Christopher Park, M.R.I.C.S.,  
Chartered Surveyor,  
R.I.C.S. Registered Valuer.

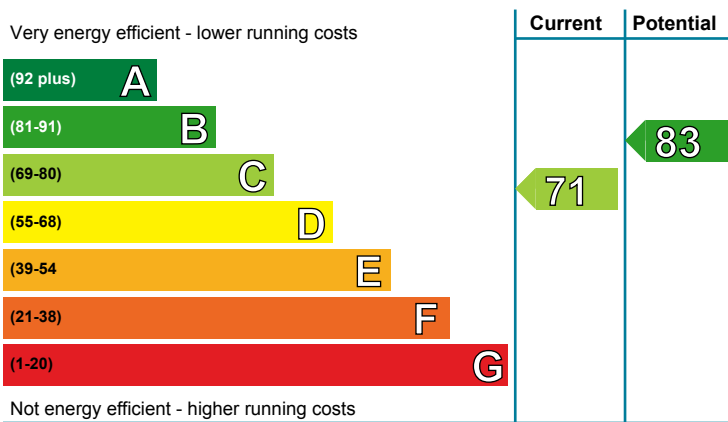
## Energy Efficiency Rating

This graph shows the current efficiency of your home, taking into account both energy efficiency and fuel costs. The higher this rating, the lower your fuel bills are likely to be.

Your current rating is **band C (71)**. The average rating for EPCs in Scotland is **band D (61)**.

The potential rating shows the effect of undertaking all of the improvement measures listed within your recommendations report.

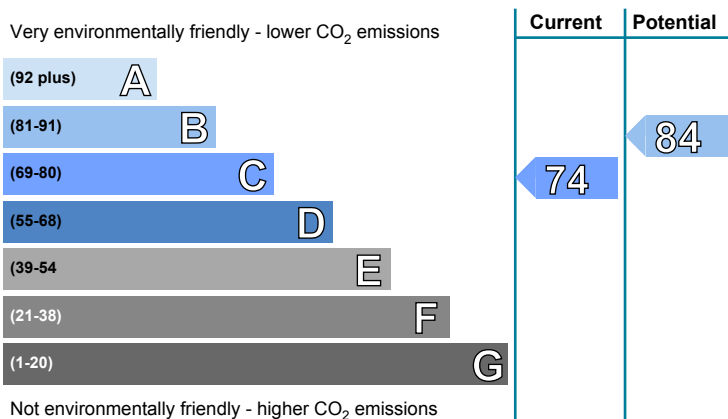
## Environmental Impact (CO<sub>2</sub>) Rating

This graph shows the effect of your home on the environment in terms of carbon dioxide (CO<sub>2</sub>) emissions. The higher the rating, the less impact it has on the environment.
