Property address: Nyumbani
Scorradale Road
Orphir
Orkney
KW16 3JA

Date of inspection: 25 August 2016

Home Report

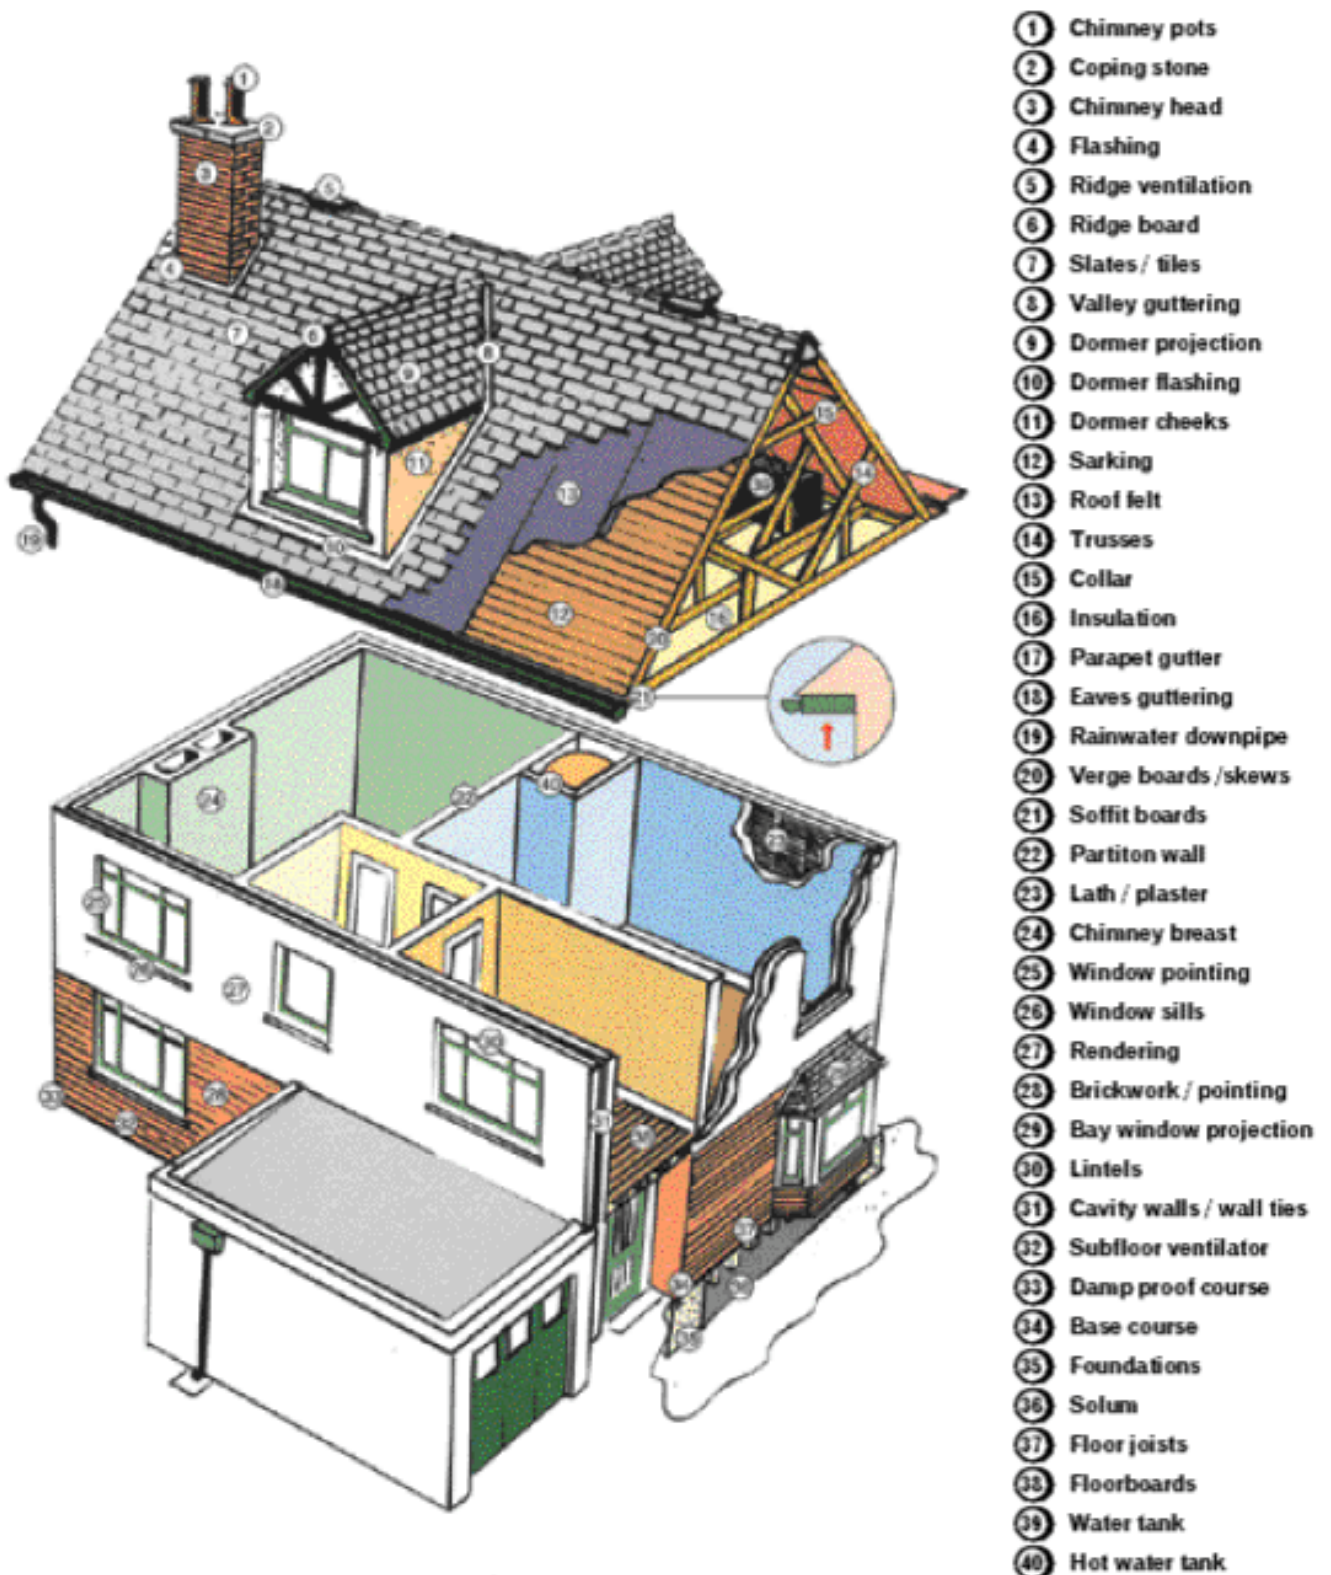
Sectional diagram showing elements of a typical house

Reference may be made in this report to some or all of the above component parts of the property. This diagram may assist you in locating and understanding these terms.
