Survey Report On

5 Bridge Street Wynd, Kirkwall, Orkney, KW15 1JD.

Date of inspection: 26th March 2024.

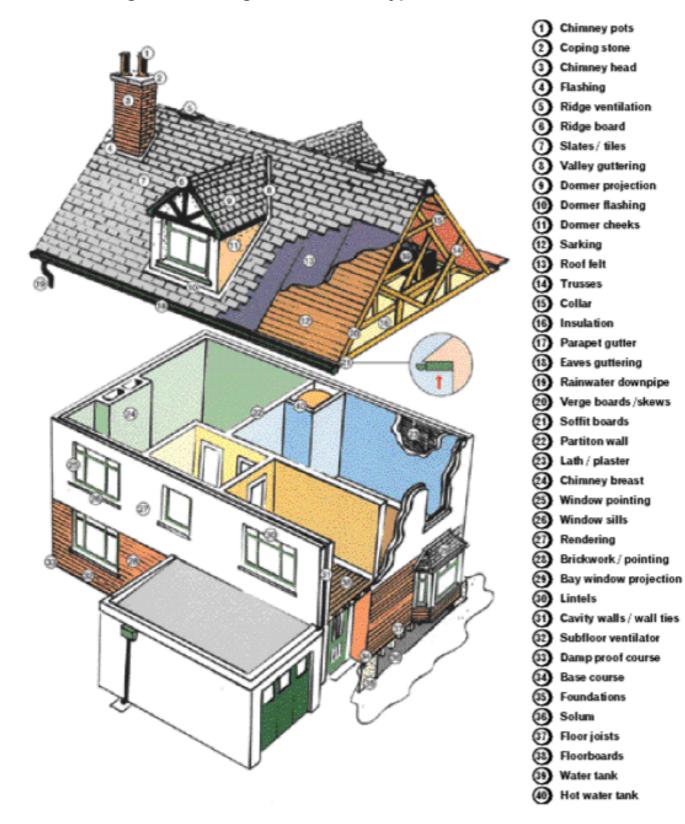
Sectional diagram showing elements of a typical house

Reference may be made in this report to some or all of the above component parts of the property. This diagram may assist you in locating and understanding these terms.
