Survey Report On

**Kingsdale Lodge,
Kingsdale Road,
Grimbister,
Firth,
Orkney,
KW15 1TT**

Date of Initial Inspection: 19th September 2023.

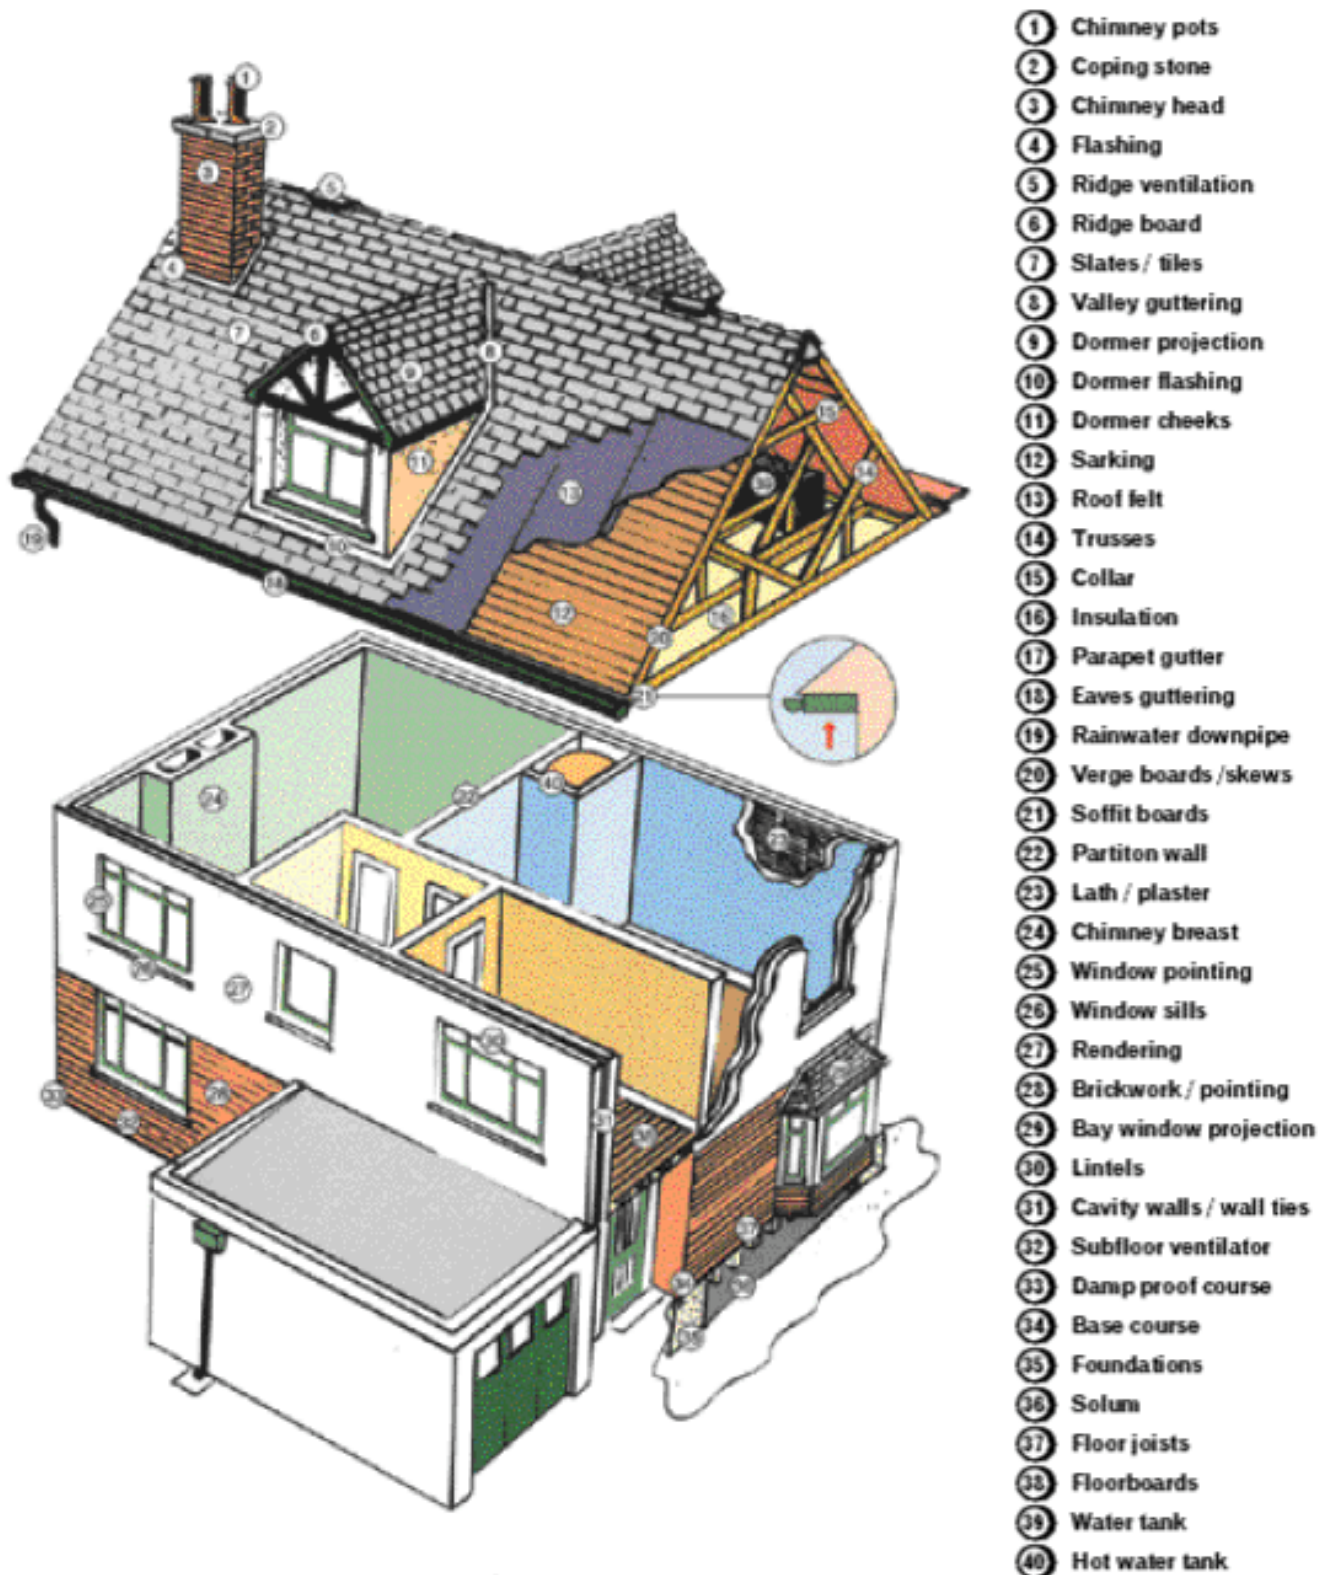
Sectional diagram showing elements of a typical house

Reference may be made in this report to some or all of the above component parts of the property. This diagram may assist you in locating and understanding these terms.

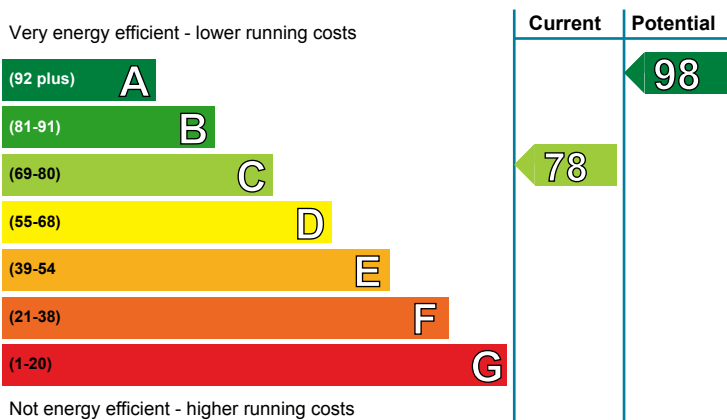
Energy Efficiency Rating

This graph shows the current efficiency of your home, taking into account both energy efficiency and fuel costs. The higher this rating, the lower your fuel bills are likely to be.

Your current rating is **band C (78)**. The average rating for EPCs in Scotland is **band D (61)**.

The potential rating shows the effect of undertaking all of the improvement measures listed within your recommendations report.
