Survey Report On

**Anchor Cottage,
Sanday,
Orkney,
KW17 2BW**

Date of inspection: 9th January 2024.

Prepared by: Christopher J Omand, BSc (Hons), M.R.I.C.S.,
Chartered Valuation Surveyor,
R.I.C.S. Registered Valuer.

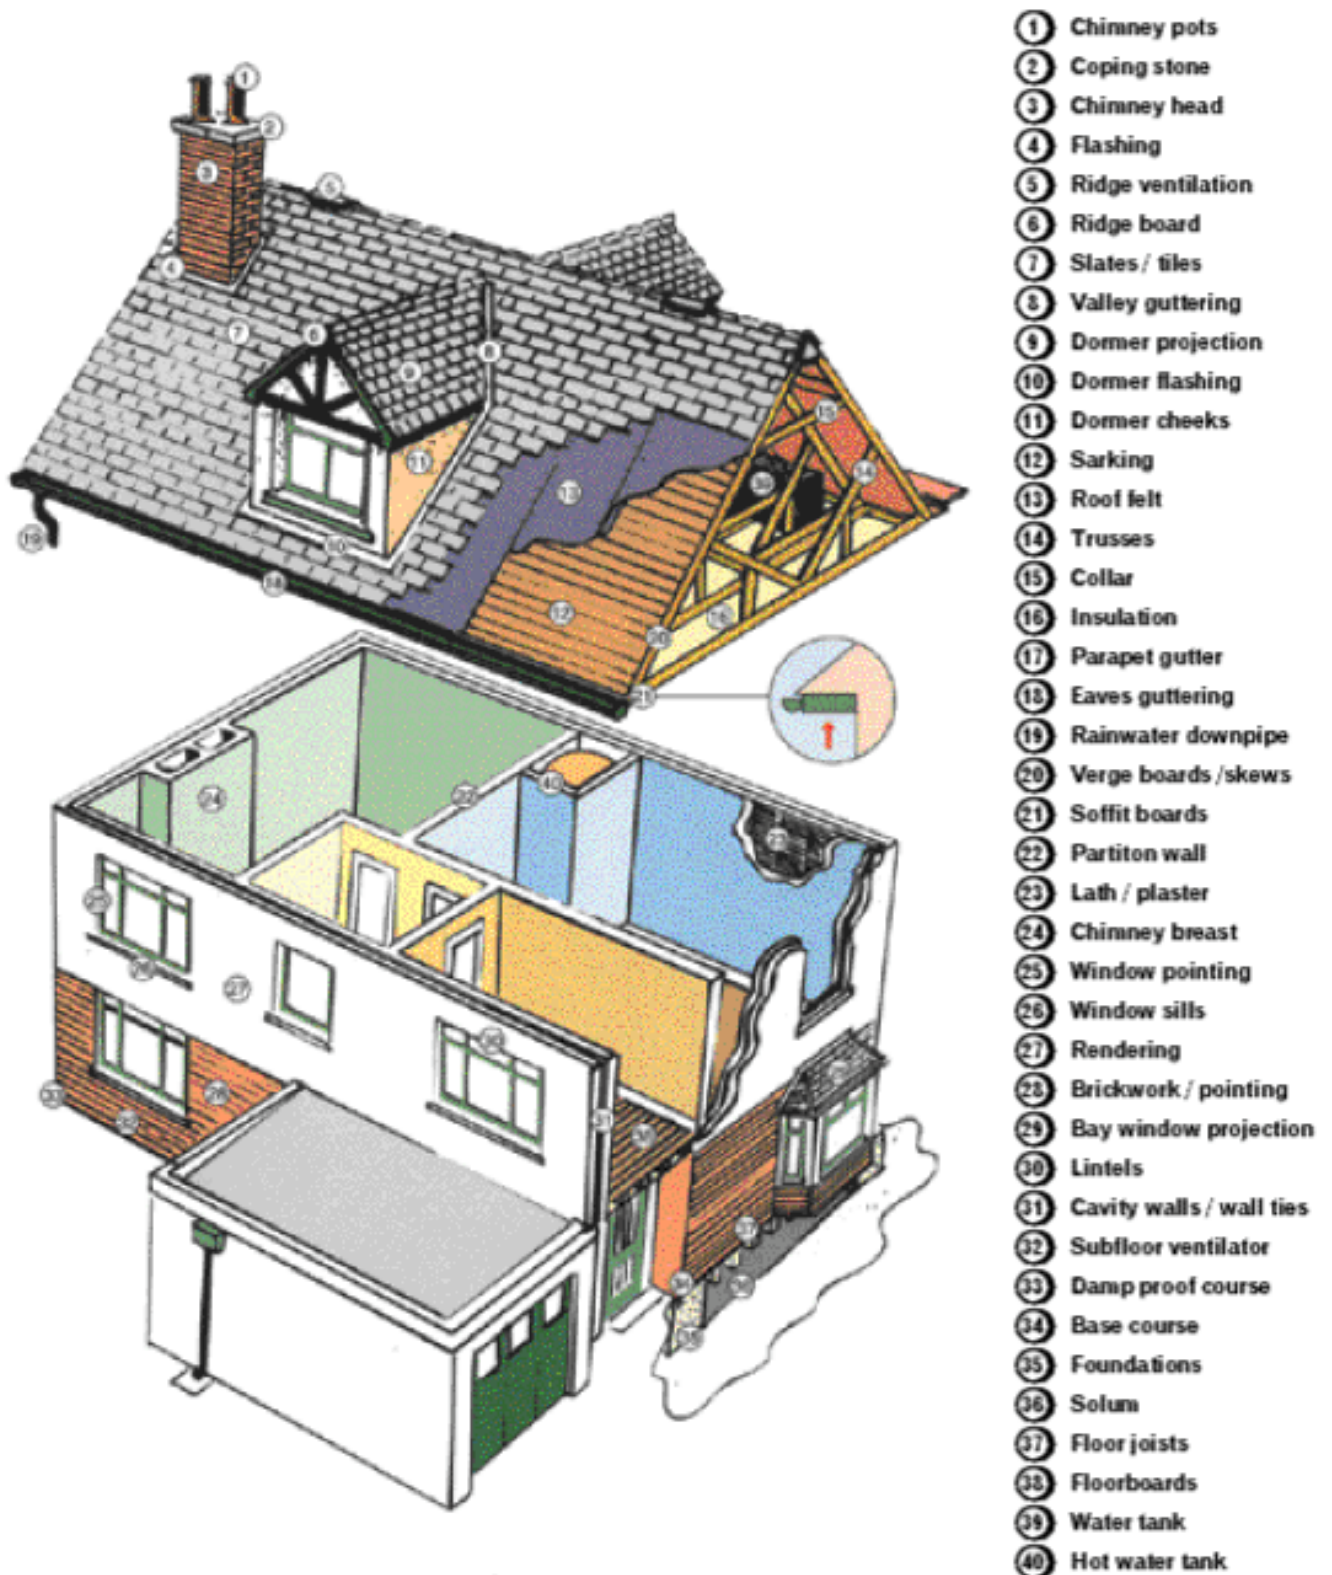
Sectional diagram showing elements of a typical house

Reference may be made in this report to some or all of the above component parts of the property. This diagram may assist you in locating and understanding these terms.

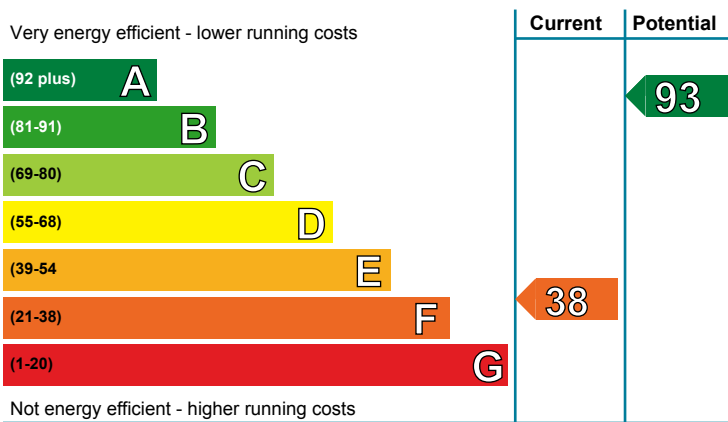
Energy Efficiency Rating

This graph shows the current efficiency of your home, taking into account both energy efficiency and fuel costs. The higher this rating, the lower your fuel bills are likely to be.

Your current rating is **band F (38)**. The average rating for EPCs in Scotland is **band D (61)**.

The potential rating shows the effect of undertaking all of the improvement measures listed within your recommendations report.
