Survey Report On

> Rickla, Harray, Orkney, KW17 2JT.

Client: Mr Philip Cook and Mrs Jane Cook.

Date of inspection: 22<sup>nd</sup> June 2023.

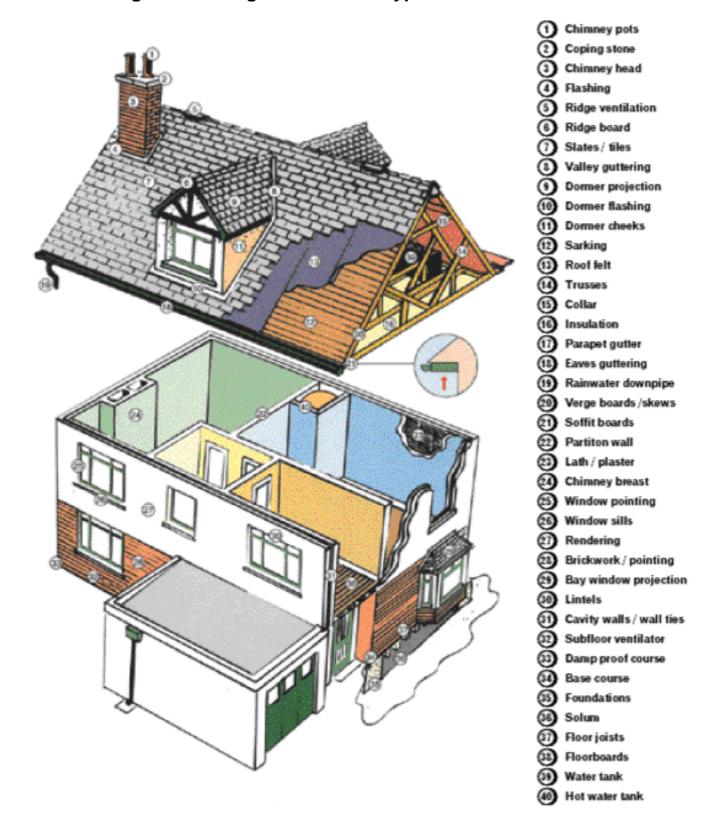
### Sectional diagram showing elements of a typical house

Reference may be made in this report to some or all of the above component parts of the property. This diagram may assist you in locating and understanding these terms.
