**SCHEDULE 1**

**Survey Report  
On**

**18 South End.  
Stromness,  
KW16 3DJ.**

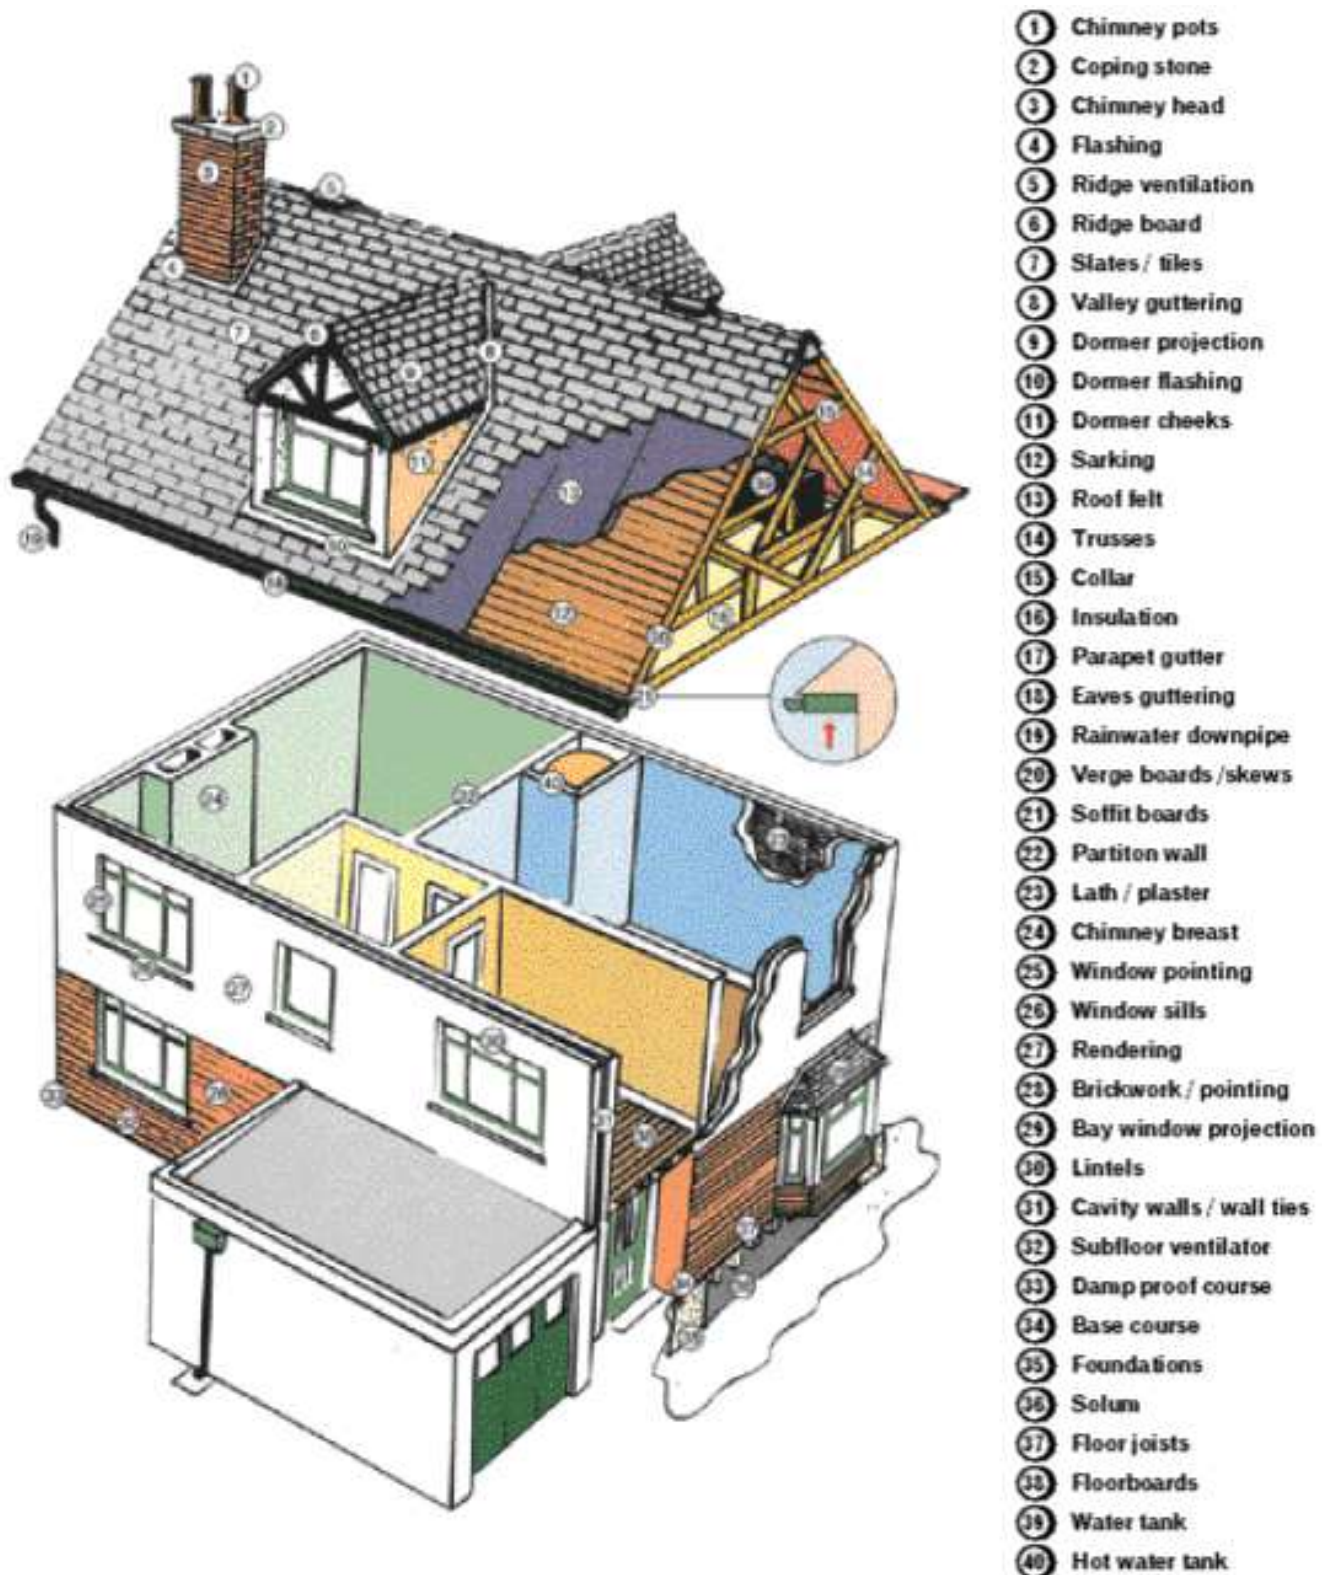
## Sectional diagram showing elements of a typical house

Reference may be made in this report to some or all of the above component parts of the property. This diagram may assist you in locating and understanding these terms.
