# **Home Report**

6 Ivydean
Junction Road
Kirkwall
Orkney
KW15 1AX

**Property address:** 6 lvydean

**Date of inspection:** 11<sup>th</sup> April 2024

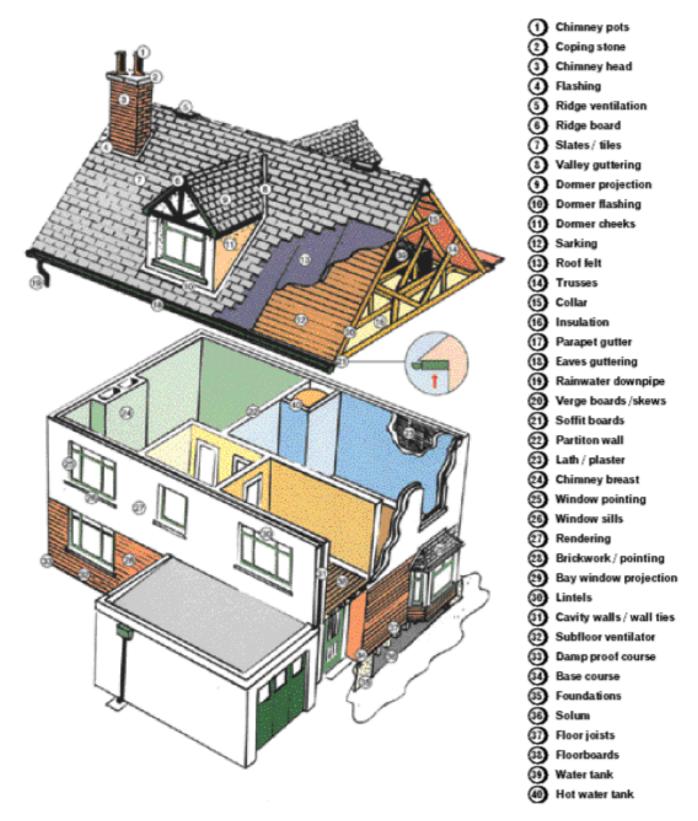
## Sectional diagram showing elements of a typical house

Reference may be made in this report to some or all of the above component parts of the property. This diagram may assist you in locating and understanding these terms.
