Property address: Hestia
Harray
Orkney
KW17 2LQ

Date of inspection: 22 August 2013

Home Report

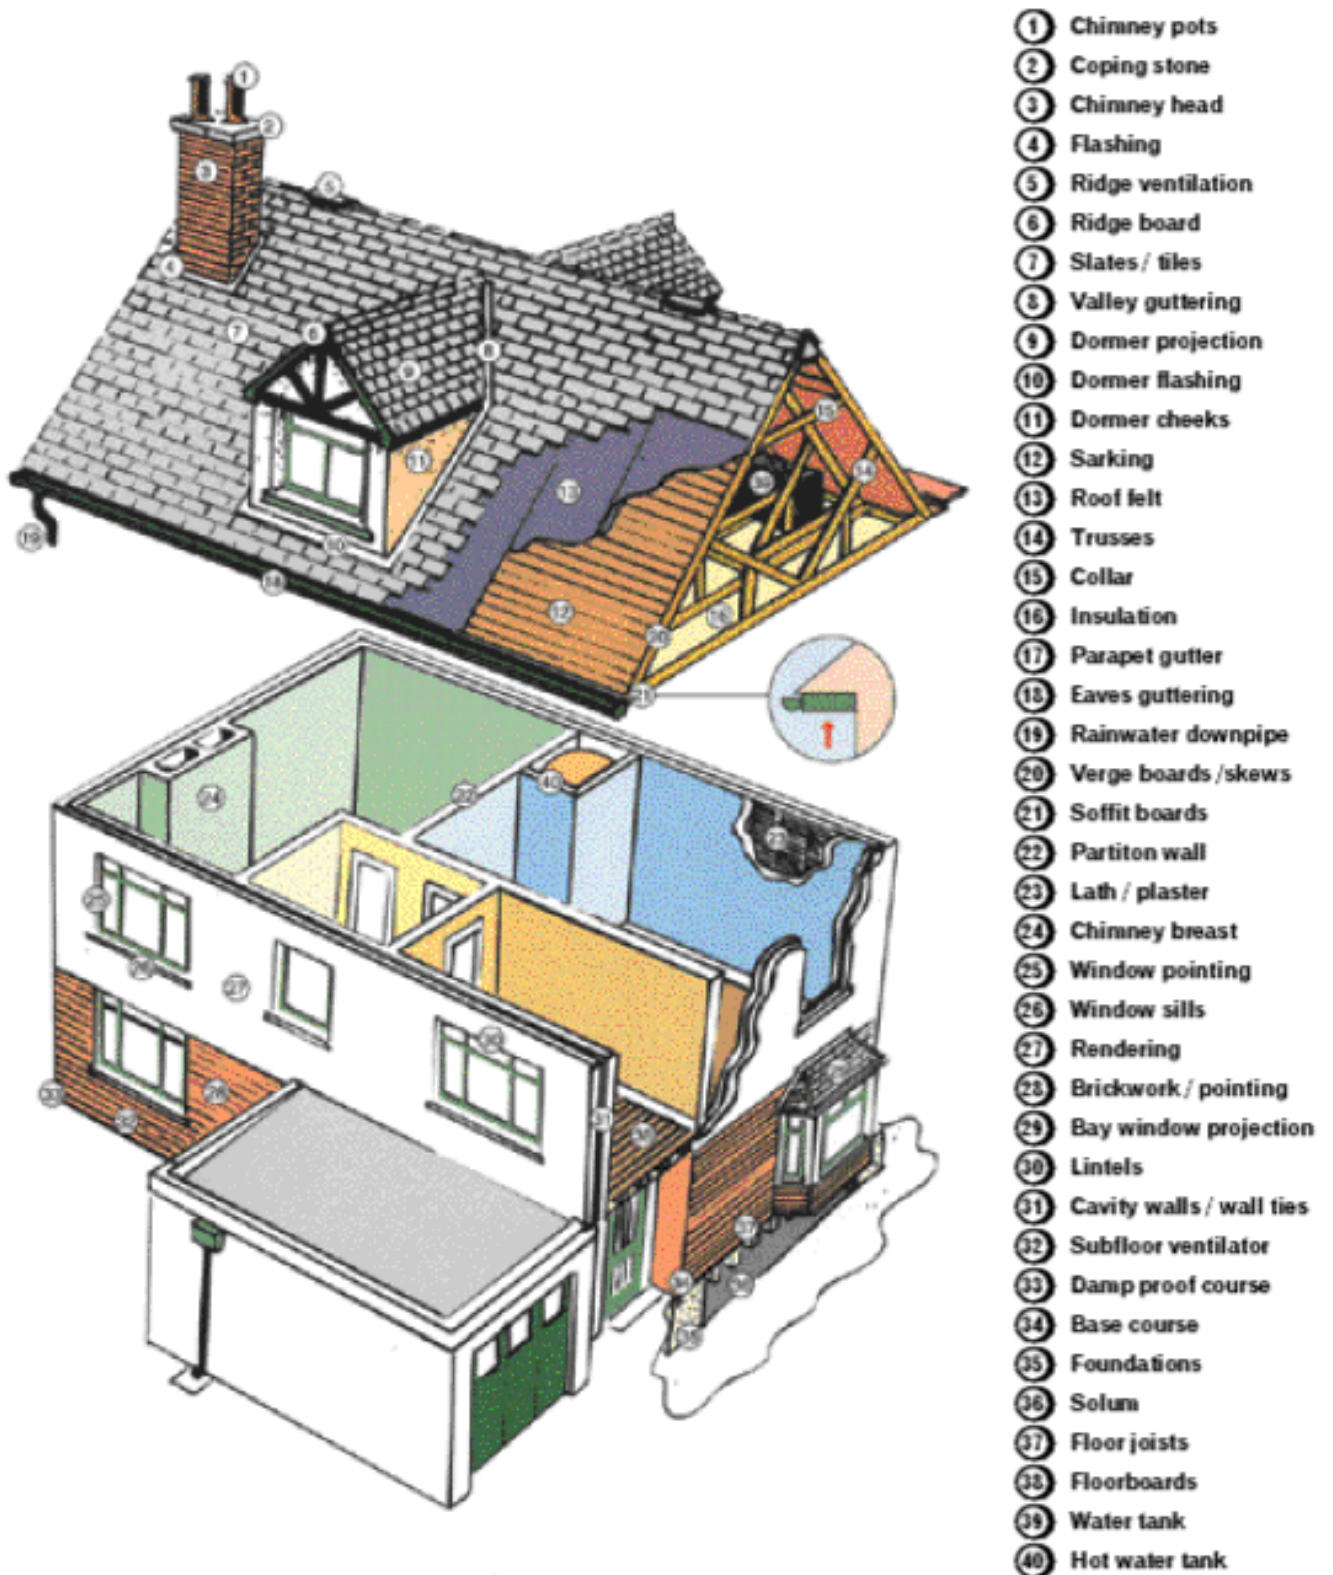
Sectional diagram showing elements of a typical house

- ① Chimney pots
- ② Coping stone
- ③ Chimney head
- ④ Flashing
- ⑤ Ridge ventilation
- ⑥ Ridge board
- ⑦ Slates / tiles
- ⑧ Valley guttering
- ⑨ Dormer projection
- ⑩ Dormer flashing
- ⑪ Dormer cheeks
- ⑫ Sarking
- ⑬ Roof felt
- ⑭ Trusses
- ⑮ Collar
- ⑯ Insulation
- ⑰ Parapet gutter
- ⑱ Eaves guttering
- ⑲ Rainwater downpipe
- ⑳ Verge boards /skews
- ㉑ Soffit boards
- ㉒ Partiton wall
- ㉓ Lath / plaster
- ㉔ Chimney breast
- ㉕ Window pointing
- ㉖ Window sills
- ㉗ Rendering
- ㉘ Brickwork / pointing
- ㉙ Bay window projection
- ㉚ Lintels
- ㉛ Cavity walls / wall ties
- ㉜ Subfloor ventilator
- ㉝ Damp proof course
- ㉞ Base course
- ㉟ Foundations
- ㊱ Solum
- ㊲ Floor joists
- ㊳ Floorboards
- ㊴ Water tank
- ㊵ Hot water tank

Reference may be made in this report to some or all of the above component parts of the property. This diagram may assist you in locating and understanding these terms.
