## Survey Report On

**Old Nisthouse,  
Mirbister  
Harray,  
Orkney,  
KW17 2LQ.**

**Date of inspection:** 9<sup>th</sup> February 2023.

**Prepared by:** Christopher Park, M.R.I.C.S.,  
Chartered Surveyor,  
R.I.C.S. Registered Valuer.

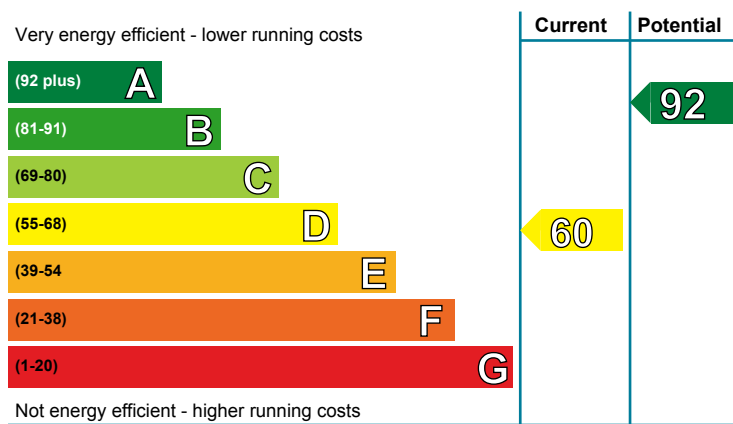
## Energy Efficiency Rating

This graph shows the current efficiency of your home, taking into account both energy efficiency and fuel costs. The higher this rating, the lower your fuel bills are likely to be.

Your current rating is **band D (60)**. The average rating for EPCs in Scotland is **band D (61)**.

The potential rating shows the effect of undertaking all of the improvement measures listed within your recommendations report.
