# Home Report

**Waverley**  
**31 Victoria Street**  
**Stromness**  
**Orkney**  
**KW16 3AA**

**Property address:** Waverley  
31 Victoria Street  
Stromness  
Orkney  
KW16 3AA

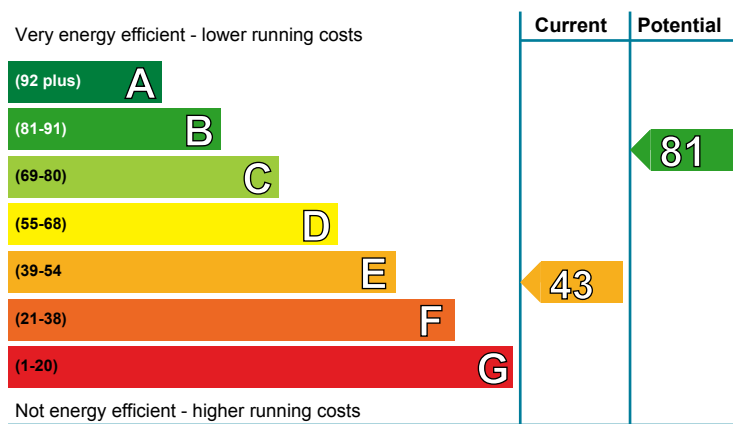
## Energy Efficiency Rating

This graph shows the current efficiency of your home, taking into account both energy efficiency and fuel costs. The higher this rating, the lower your fuel bills are likely to be.

Your current rating is **band E (43)**. The average rating for EPCs in Scotland is **band D (61)**.

The potential rating shows the effect of undertaking all of the improvement measures listed within your recommendations report.

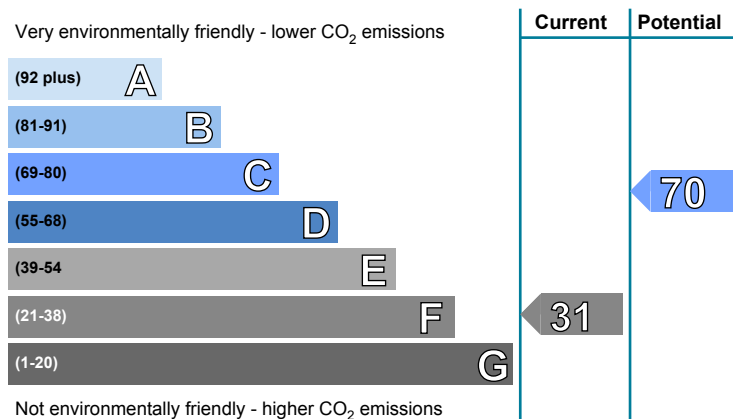
## Environmental Impact (CO<sub>2</sub>) Rating

This graph shows the effect of your home on the environment in terms of carbon dioxide (CO<sub>2</sub>) emissions. The higher the rating, the less impact it has on the environment.
