Survey Report On

**Hazelbank,
Stronsay,
Orkney,
KW17 2AE.**

Client: Mrs Jean A Smale.

Date of inspection: 25th October 2023.

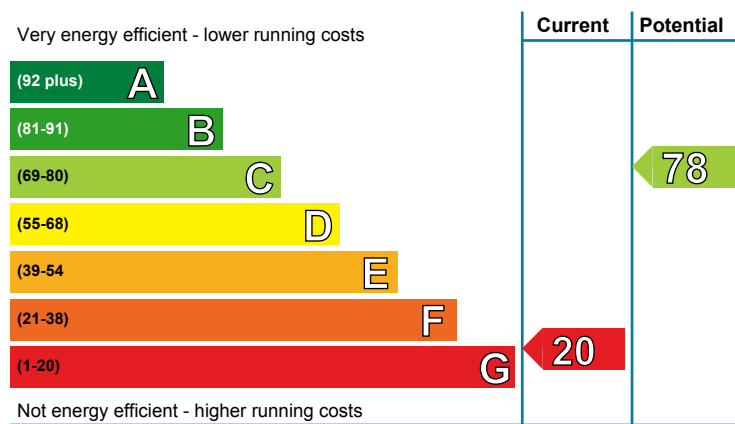
Energy Efficiency Rating

This graph shows the current efficiency of your home, taking into account both energy efficiency and fuel costs. The higher this rating, the lower your fuel bills are likely to be.

Your current rating is **band G (20)**. The average rating for EPCs in Scotland is **band D (61)**.

The potential rating shows the effect of undertaking all of the improvement measures listed within your recommendations report.

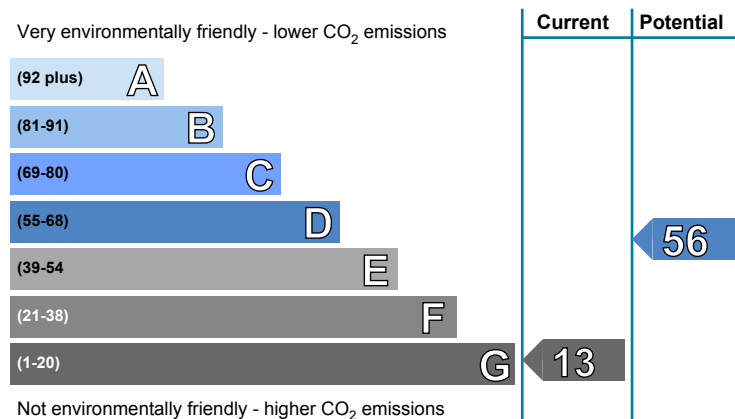
Environmental Impact (CO₂) Rating

This graph shows the effect of your home on the environment in terms of carbon dioxide (CO₂) emissions. The higher the rating, the less impact it has on the environment.
