Survey Report On

> Burnside, Longhope, Orkney, KW16 3NQ

Date of inspection: 21st January 2025.

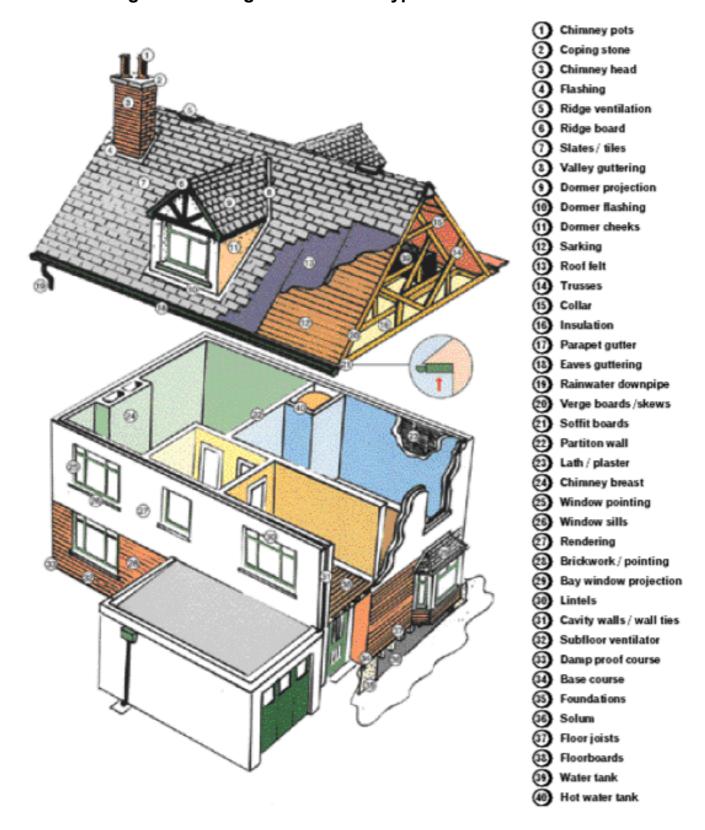
#### Sectional diagram showing elements of a typical house

Reference may be made in this report to some or all of the above component parts of the property. This diagram may assist you in locating and understanding these terms.
