### Survey Report On

2 Buttquoy Drive, Kirkwall, Orkney, KW15 1JJ.

Date of inspection: 20<sup>th</sup> March 2025.

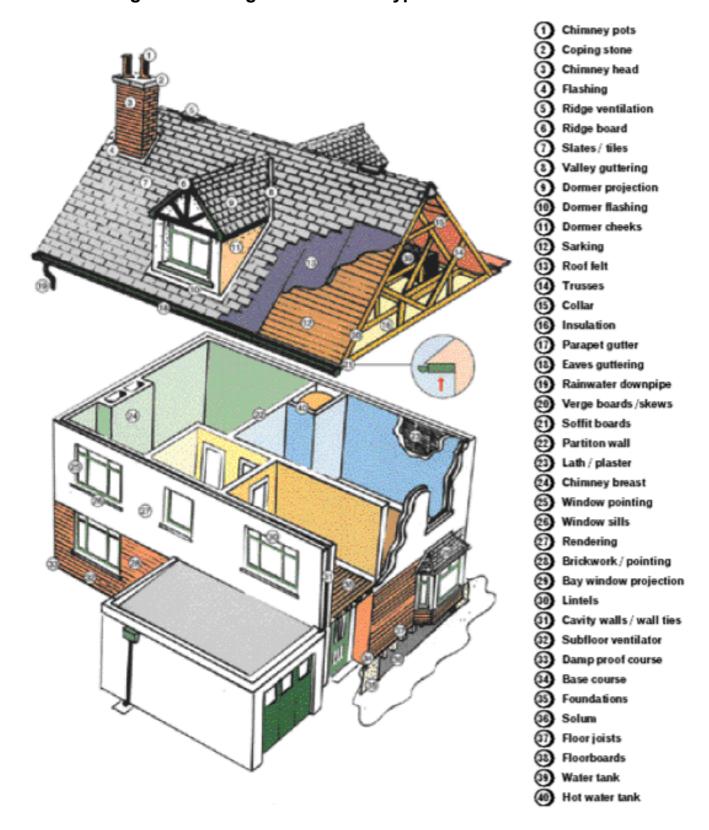
### Sectional diagram showing elements of a typical house

Reference may be made in this report to some or all of the above component parts of the property. This diagram may assist you in locating and understanding these terms.
