Survey Report On

Velzian Cottage, Puldrite Road, Rendall, Orkney, KW17 2EZ.

Date of inspection: 22nd May 2025.

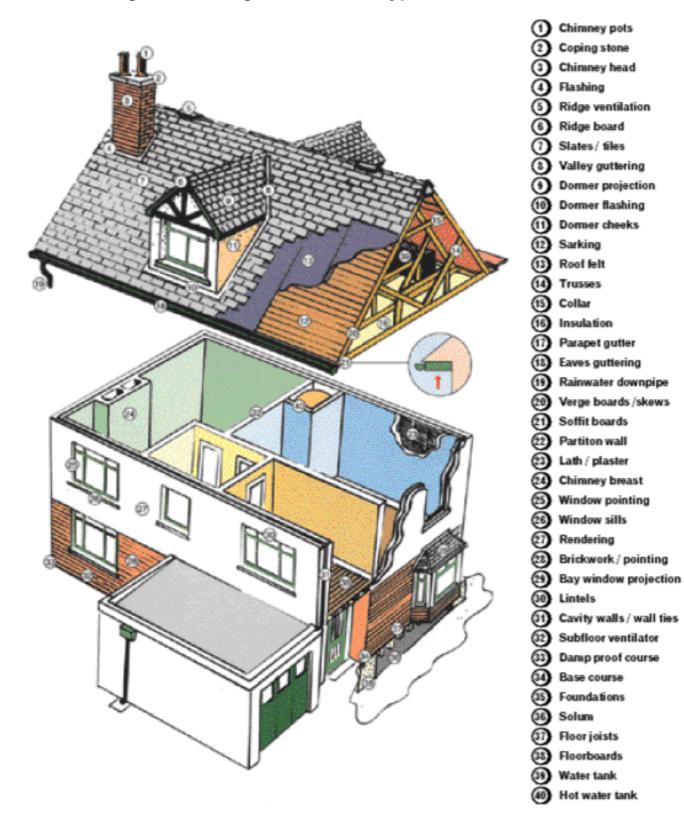
Sectional diagram showing elements of a typical house

Reference may be made in this report to some or all of the above component parts of the property. This diagram may assist you in locating and understanding these terms.
