Home Report

11 Papdale Crescent Kirkwall Orkney KW15 1JS

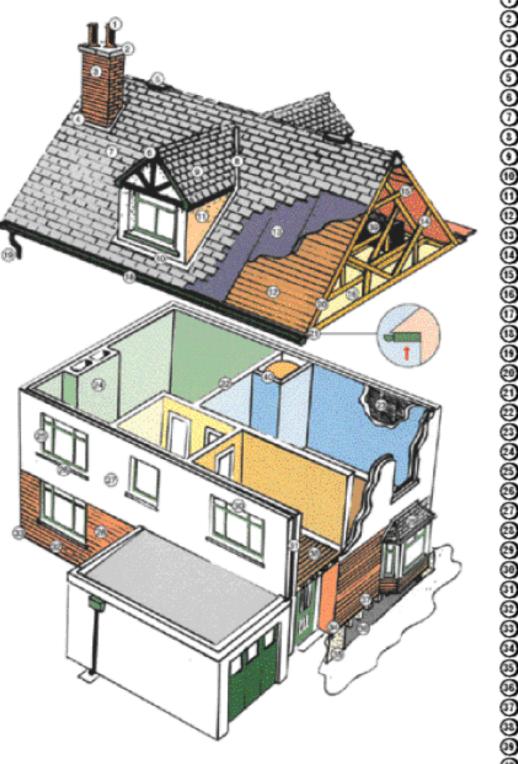
Sectional diagram showing elements of a typical house

Chimney pots 1 Coping stone Chimney head Flashing **Ridge ventilation** Ridge board Slates / tiles Valley guttering Dormer projection Dormer flashing Dormer cheeks Sarking Roof felt Trusses Collar Insulation 163 Parapet gutter Eaves guttering Rainwater downpipe Verge boards/skews Soffit boards Partiton wall Lath / plaster Chimney breast Window pointing Window sills Rendering Brickwork / pointing Bay window projection Lintels Cavity walls / wall ties Subfloor ventilator Damp proof course Base course Foundations Solum Floor joists Floorboards Water tank Hot water tank

Reference may be made in this report to some or all of the above component parts of the property. This diagram may assist you in locating and understanding these terms.
