Survey Report On

**97 Victoria Street,
Stromness,
Orkney,
KW16 3BU.**

Date of inspection: 25th April 2024.

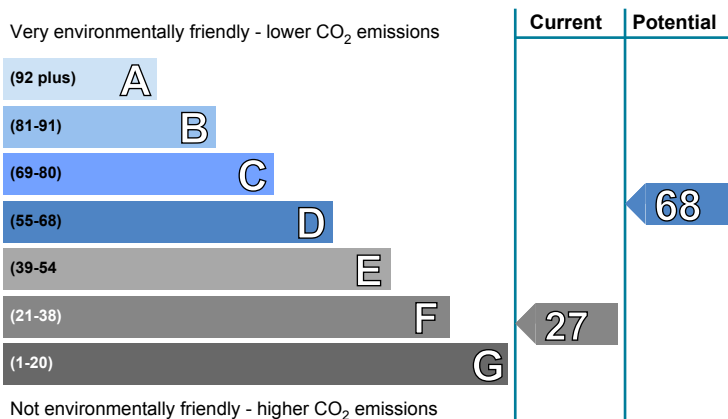
Environmental Impact (CO₂) Rating

This graph shows the effect of your home on the environment in terms of carbon dioxide (CO₂) emissions. The higher the rating, the less impact it has on the environment.
