Survey Report On

**Veskyer,
Sandwick,
Orkney,
KW16 3HZ.**

Date of inspection: 17th February 2026.

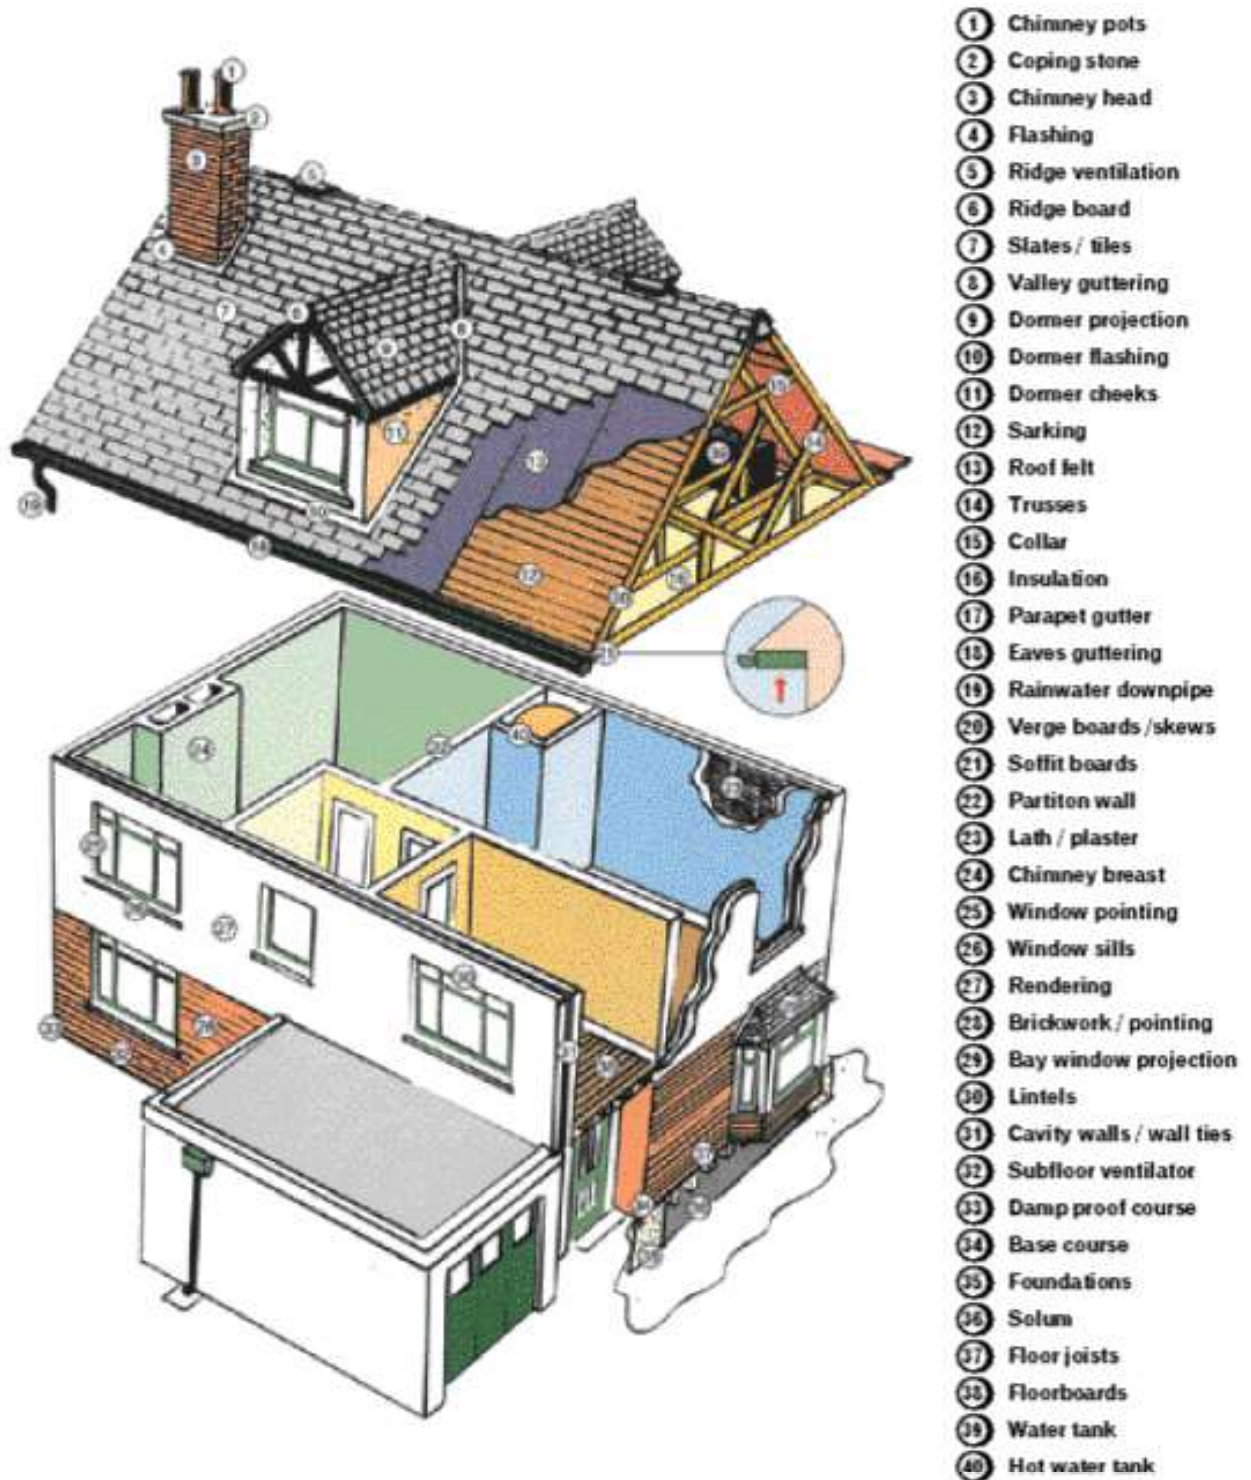
Sectional diagram showing elements of a typical house

Reference may be made in this report to some or all of the above component parts of the property. This diagram may assist you in locating and understanding these terms.

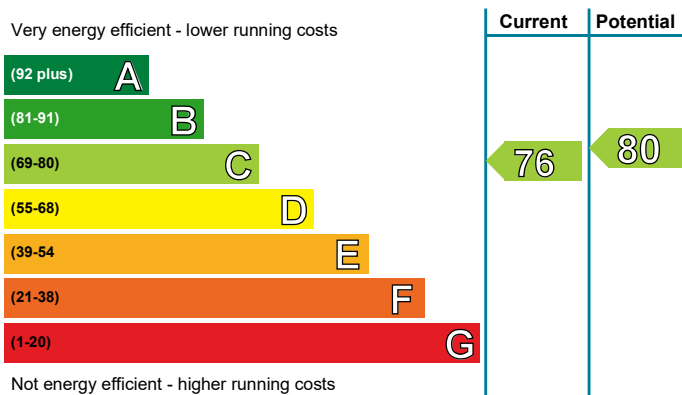
Energy Efficiency Rating

This graph shows the current efficiency of your home, taking into account both energy efficiency and fuel costs. The higher this rating, the lower your fuel bills are likely to be.

Your current rating is **band C (76)**. The average rating for EPCs in Scotland is **band D (61)**.

The potential rating shows the effect of undertaking all of the improvement measures listed within your recommendations report.

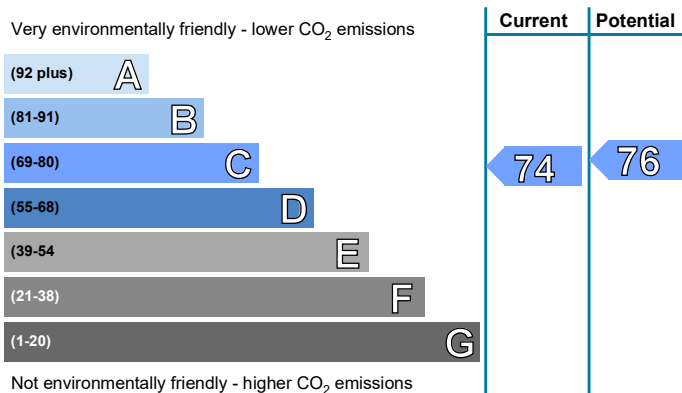
Environmental Impact (CO₂) Rating

This graph shows the effect of your home on the environment in terms of carbon dioxide (CO₂) emissions. The higher the rating, the less impact it has on the environment.
