Home Report

Denbigh
Harray
Orkney
KW17 2JS

Property address: Denbigh
Harray
Orkney
KW17 2JS

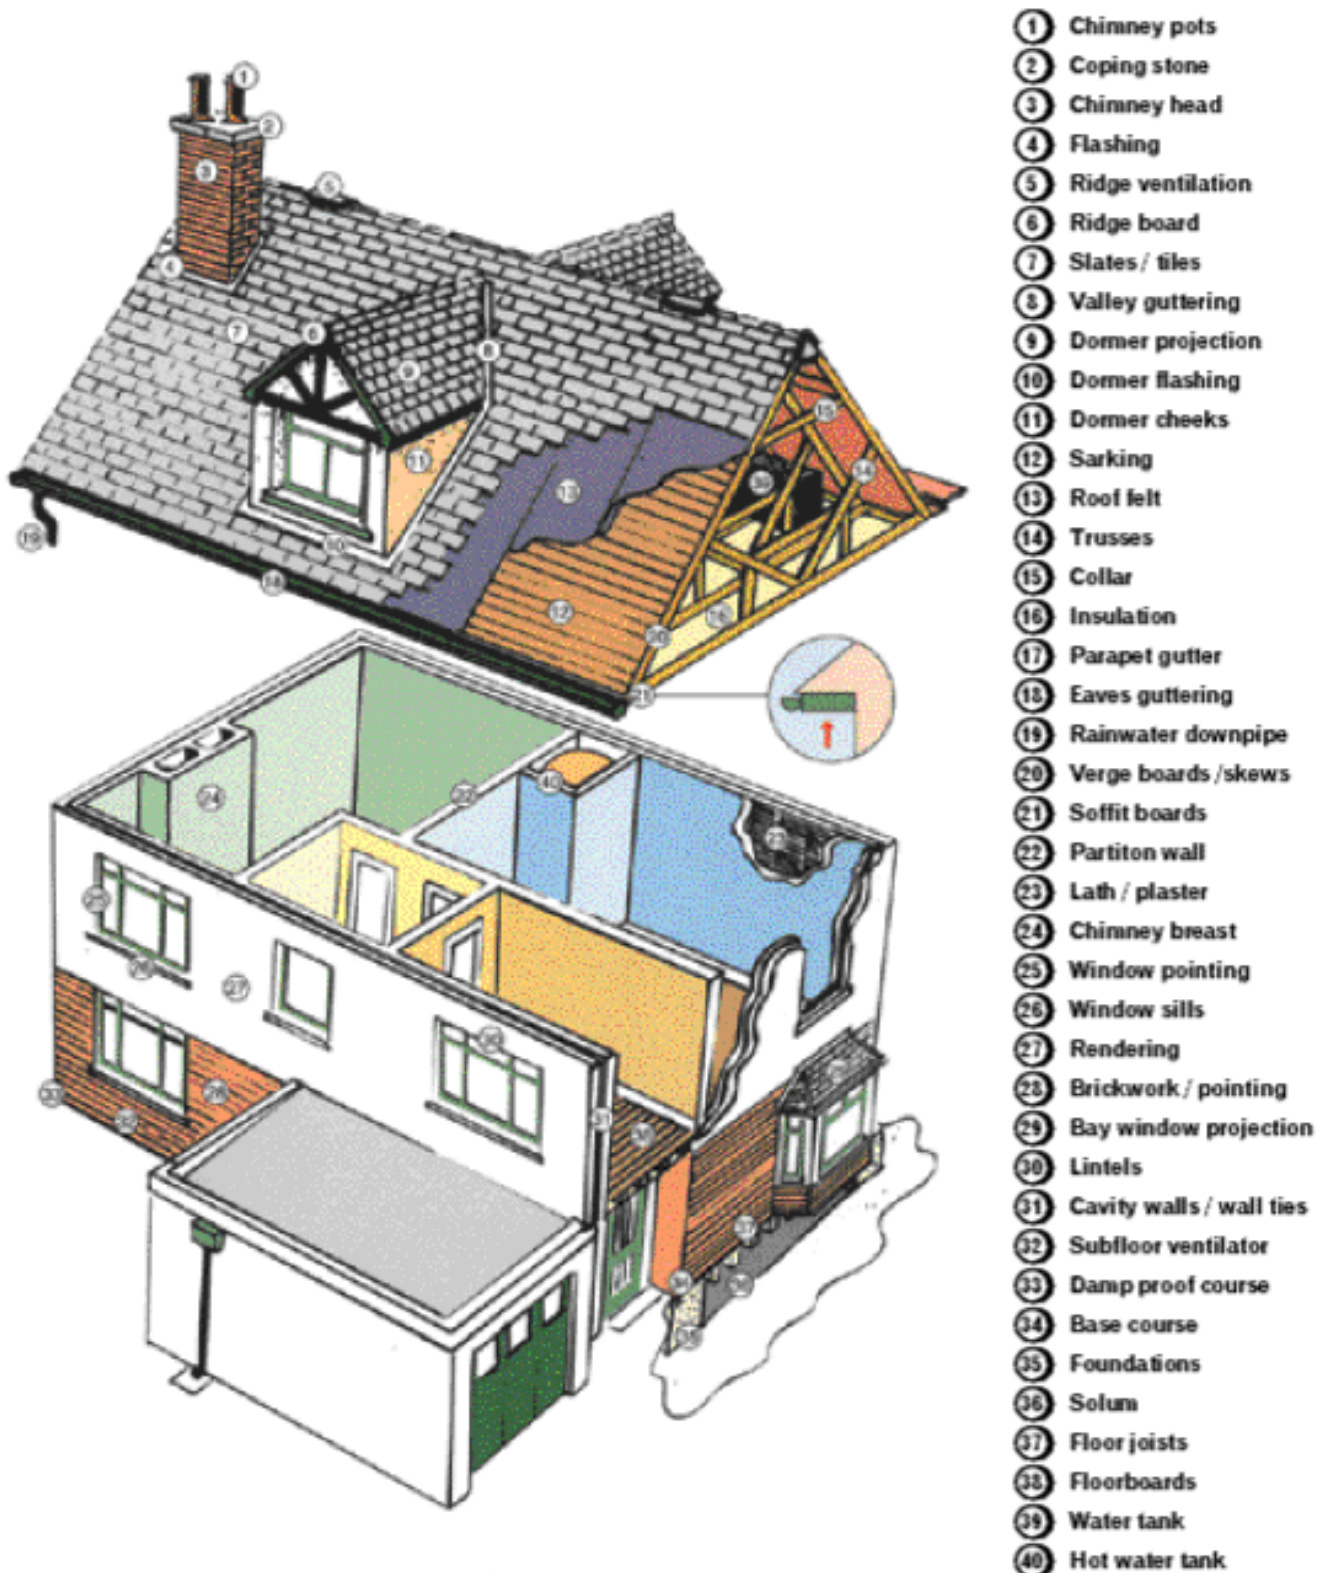
Sectional diagram showing elements of a typical house

Reference may be made in this report to some or all of the above component parts of the property. This diagram may assist you in locating and understanding these terms.

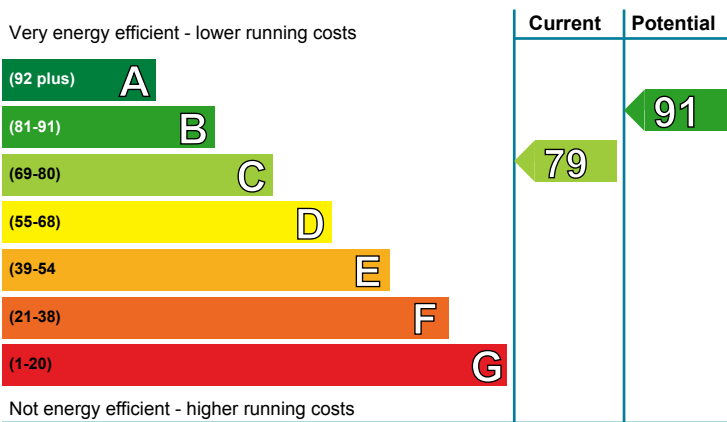
Energy Efficiency Rating

This graph shows the current efficiency of your home, taking into account both energy efficiency and fuel costs. The higher this rating, the lower your fuel bills are likely to be.

Your current rating is **band C (79)**. The average rating for EPCs in Scotland is **band D (61)**.

The potential rating shows the effect of undertaking all of the improvement measures listed within your recommendations report.

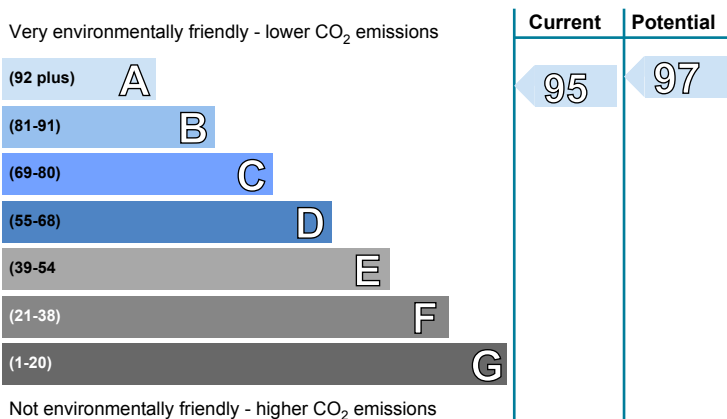
Environmental Impact (CO₂) Rating

This graph shows the effect of your home on the environment in terms of carbon dioxide (CO₂) emissions. The higher the rating, the less impact it has on the environment.
