SINGLE SURVEY

Property	Millhouse, Lyness Hoy KW16 3NU
Prepared for	
Date of Inspection	13 May 2026

SECTION 1 — INFORMATION AND SCOPE OF INSPECTION

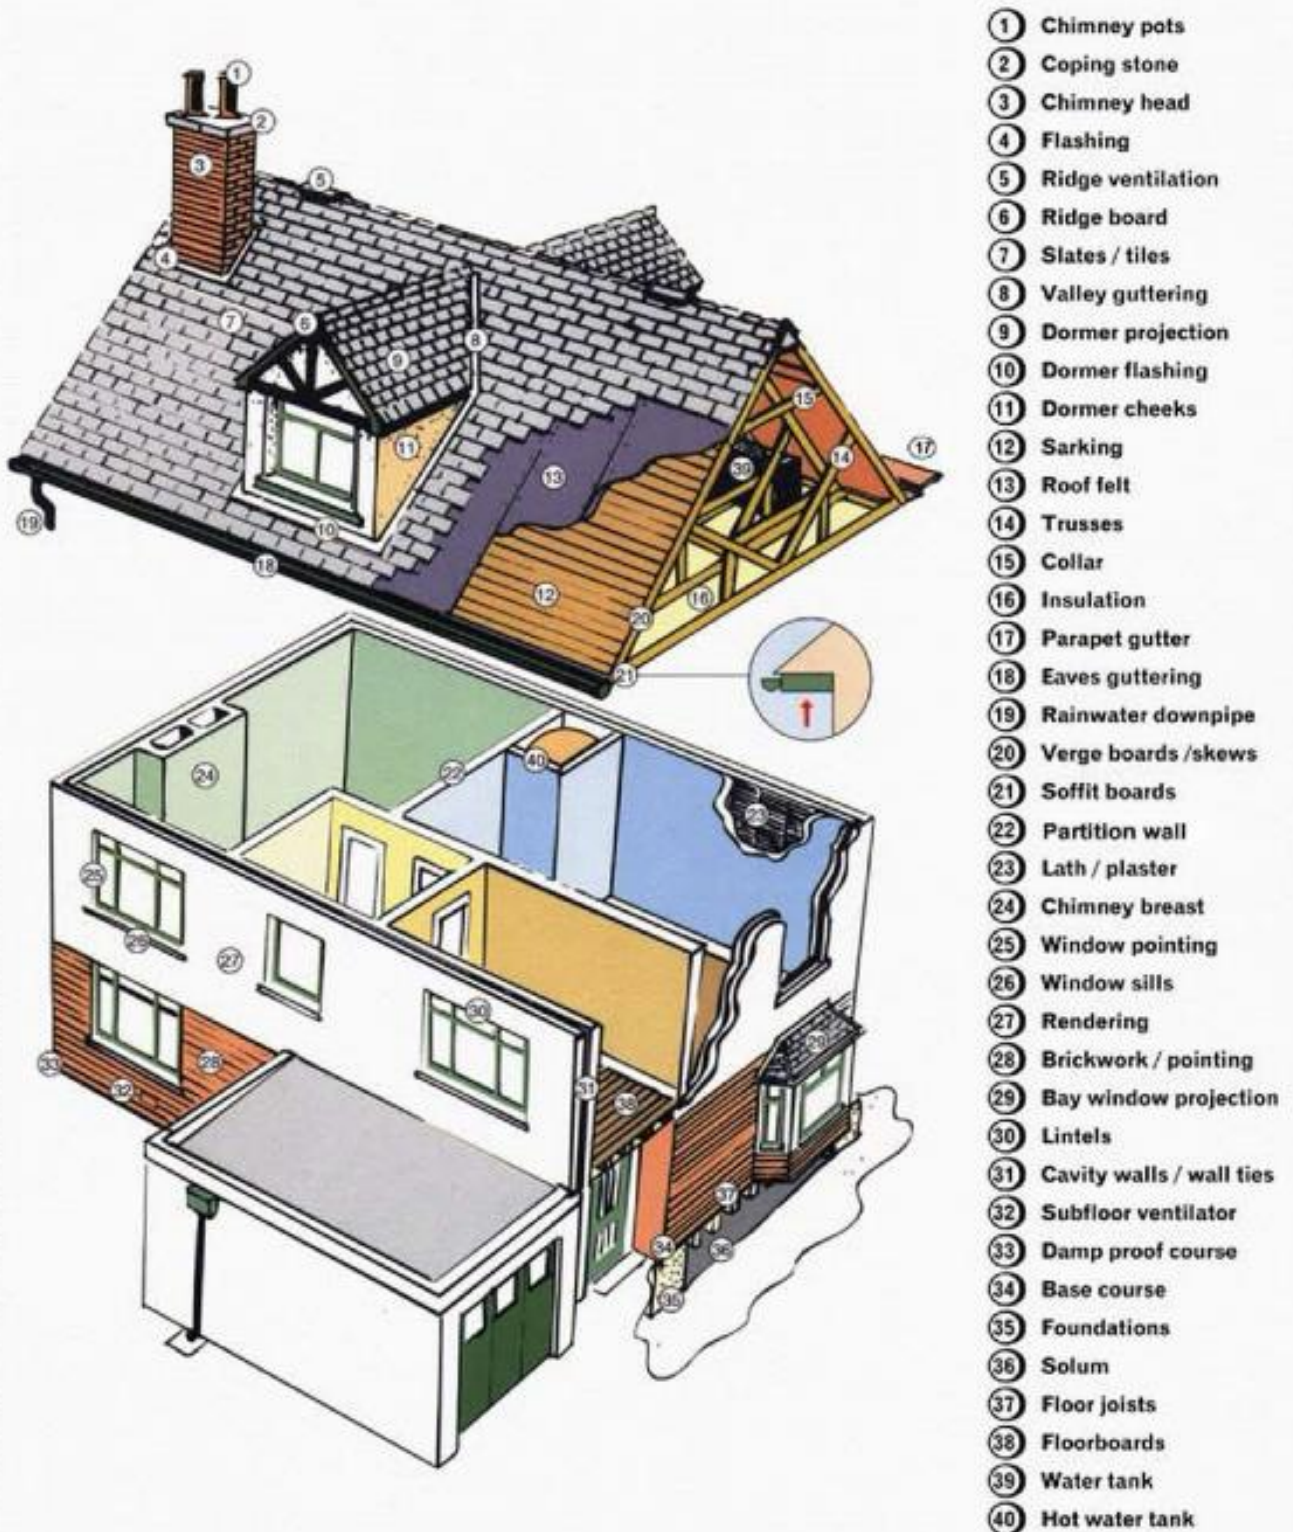
Sectional diagram showing elements of a typical house

- ① Chimney pots
- ② Coping stone
- ③ Chimney head
- ④ Flashing
- ⑤ Ridge ventilation
- ⑥ Ridge board
- ⑦ Slates / tiles
- ⑧ Valley guttering
- ⑨ Dormer projection
- ⑩ Dormer flashing
- ⑪ Dormer cheeks
- ⑫ Sarking
- ⑬ Roof felt
- ⑭ Trusses
- ⑮ Collar
- ⑯ Insulation
- ⑰ Parapet gutter
- ⑱ Eaves guttering
- ⑲ Rainwater downpipe
- ⑳ Verge boards /skews
- ㉑ Soffit boards
- ㉒ Partition wall
- ㉓ Lath / plaster
- ㉔ Chimney breast
- ㉕ Window pointing
- ㉖ Window sills
- ㉗ Rendering
- ㉘ Brickwork / pointing
- ㉙ Bay window projection
- ㉚ Lintels
- ㉛ Cavity walls / wall ties
- ㉜ Subfloor ventilator
- ㉝ Damp proof course
- ㉞ Base course
- ㉟ Foundations
- ㊱ Solum
- ㊲ Floor joists
- ㊳ Floorboards
- ㊴ Water tank
- ㊵ Hot water tank

Reference may be made in this report to some or all of the above component parts of the property. This diagram may assist you in locating and understanding these terms.

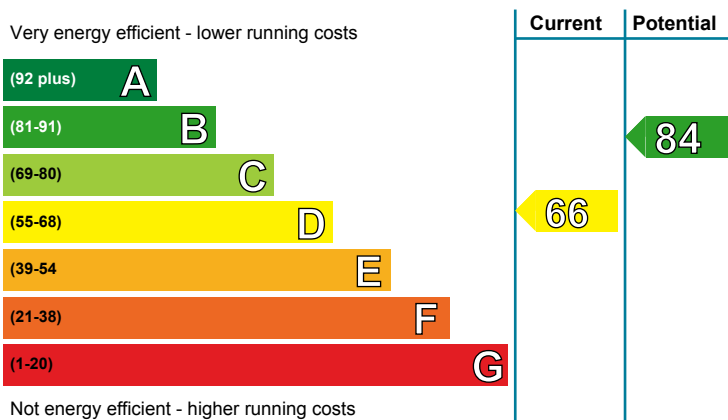
Energy Efficiency Rating

This graph shows the current efficiency of your home, taking into account both energy efficiency and fuel costs. The higher this rating, the lower your fuel bills are likely to be.

Your current rating is **band D (66)**. The average rating for EPCs in Scotland is **band D (61)**.

The potential rating shows the effect of undertaking all of the improvement measures listed within your recommendations report.

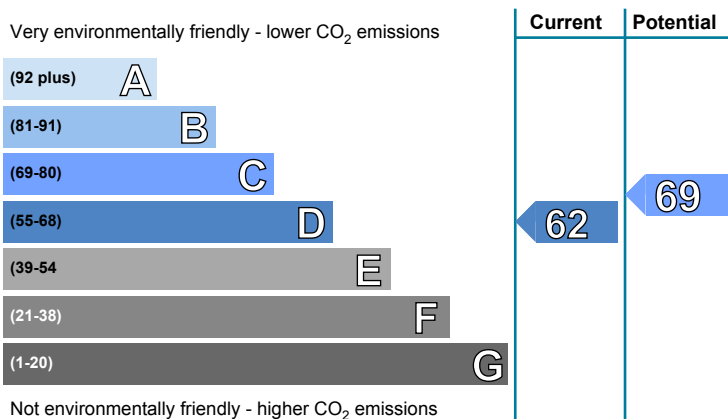
Environmental Impact (CO₂) Rating

This graph shows the effect of your home on the environment in terms of carbon dioxide (CO₂) emissions. The higher the rating, the less impact it has on the environment.
