## Survey Report On

**Allendale,  
Eday,  
Orkney,  
KW17 2AB.**

**Date of inspection:** 9<sup>th</sup> April 2025.

**Prepared by:** Christopher J Omand, BSc (Hons), M.R.I.C.S.,  
Chartered Valuation Surveyor,  
R.I.C.S. Registered Valuer.

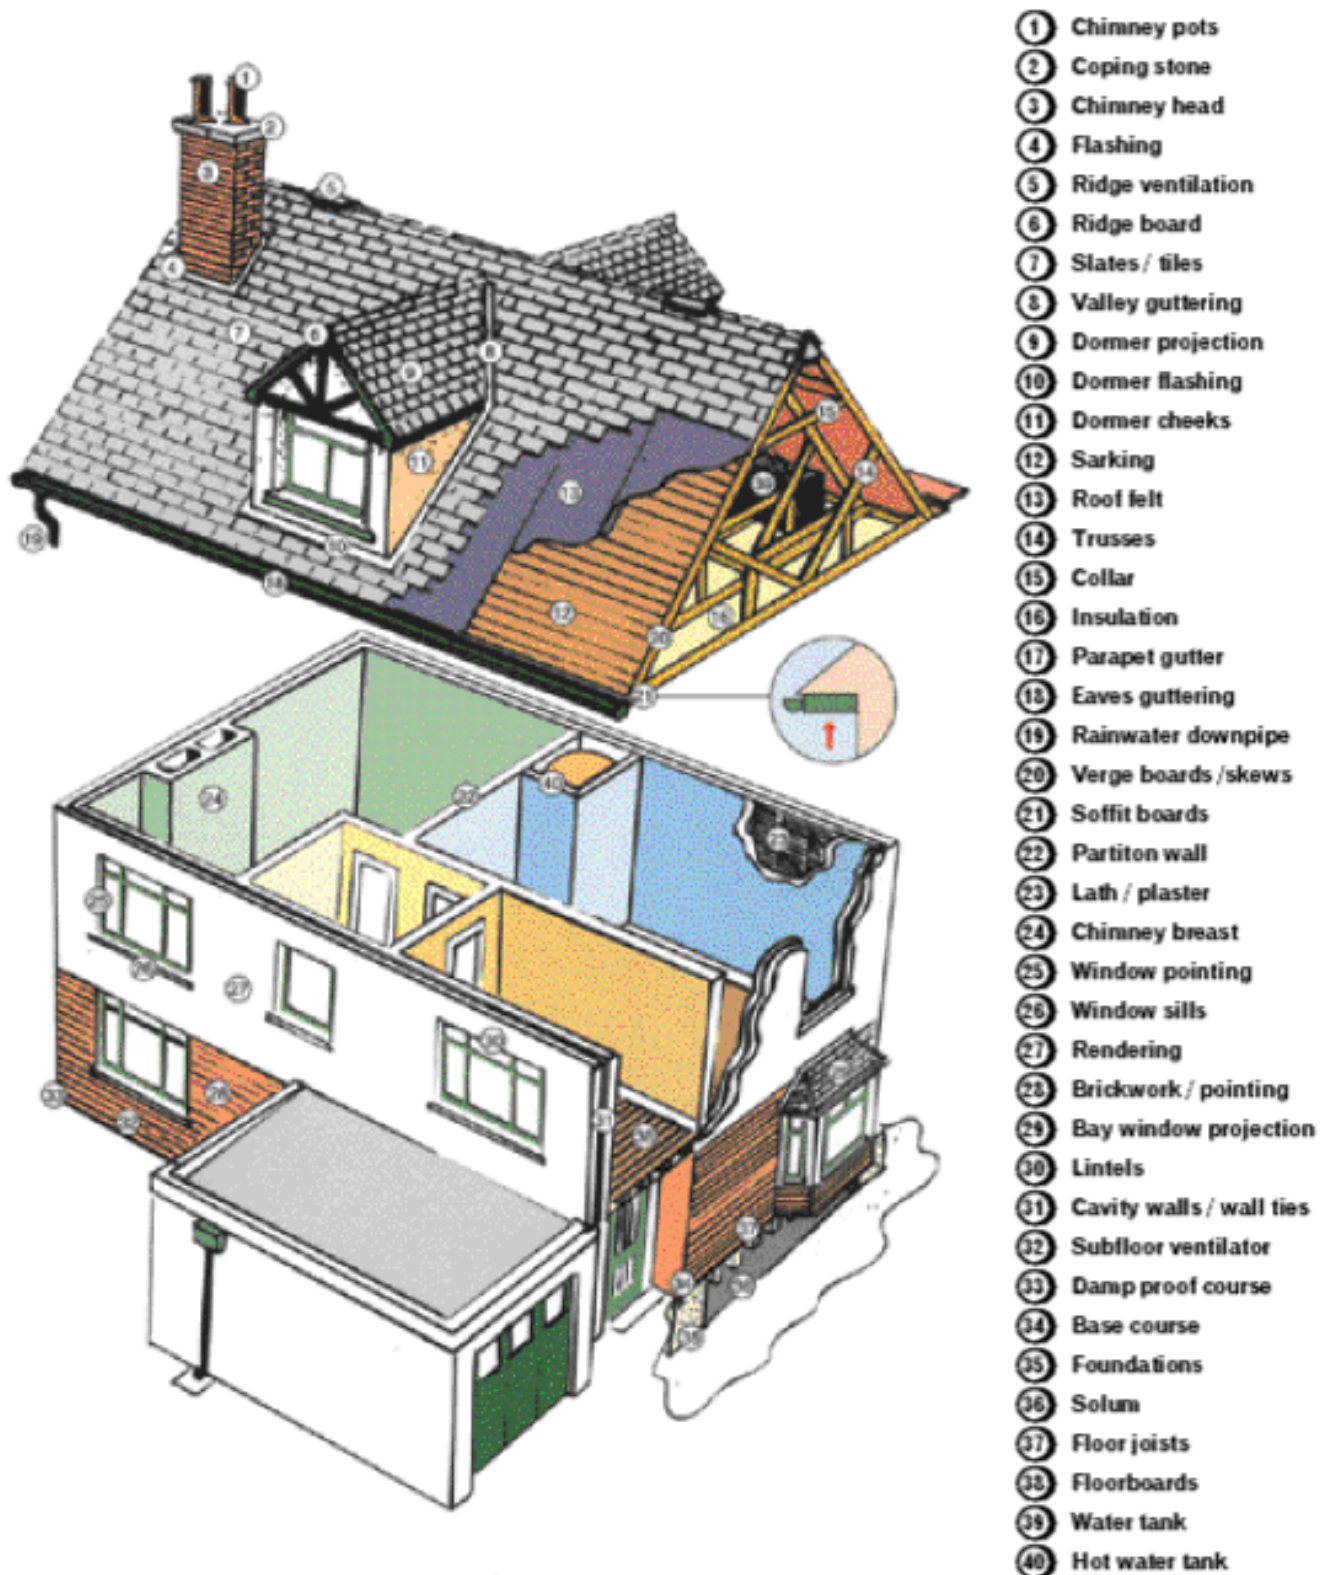
## Sectional diagram showing elements of a typical house

Reference may be made in this report to some or all of the above component parts of the property. This diagram may assist you in locating and understanding these terms.

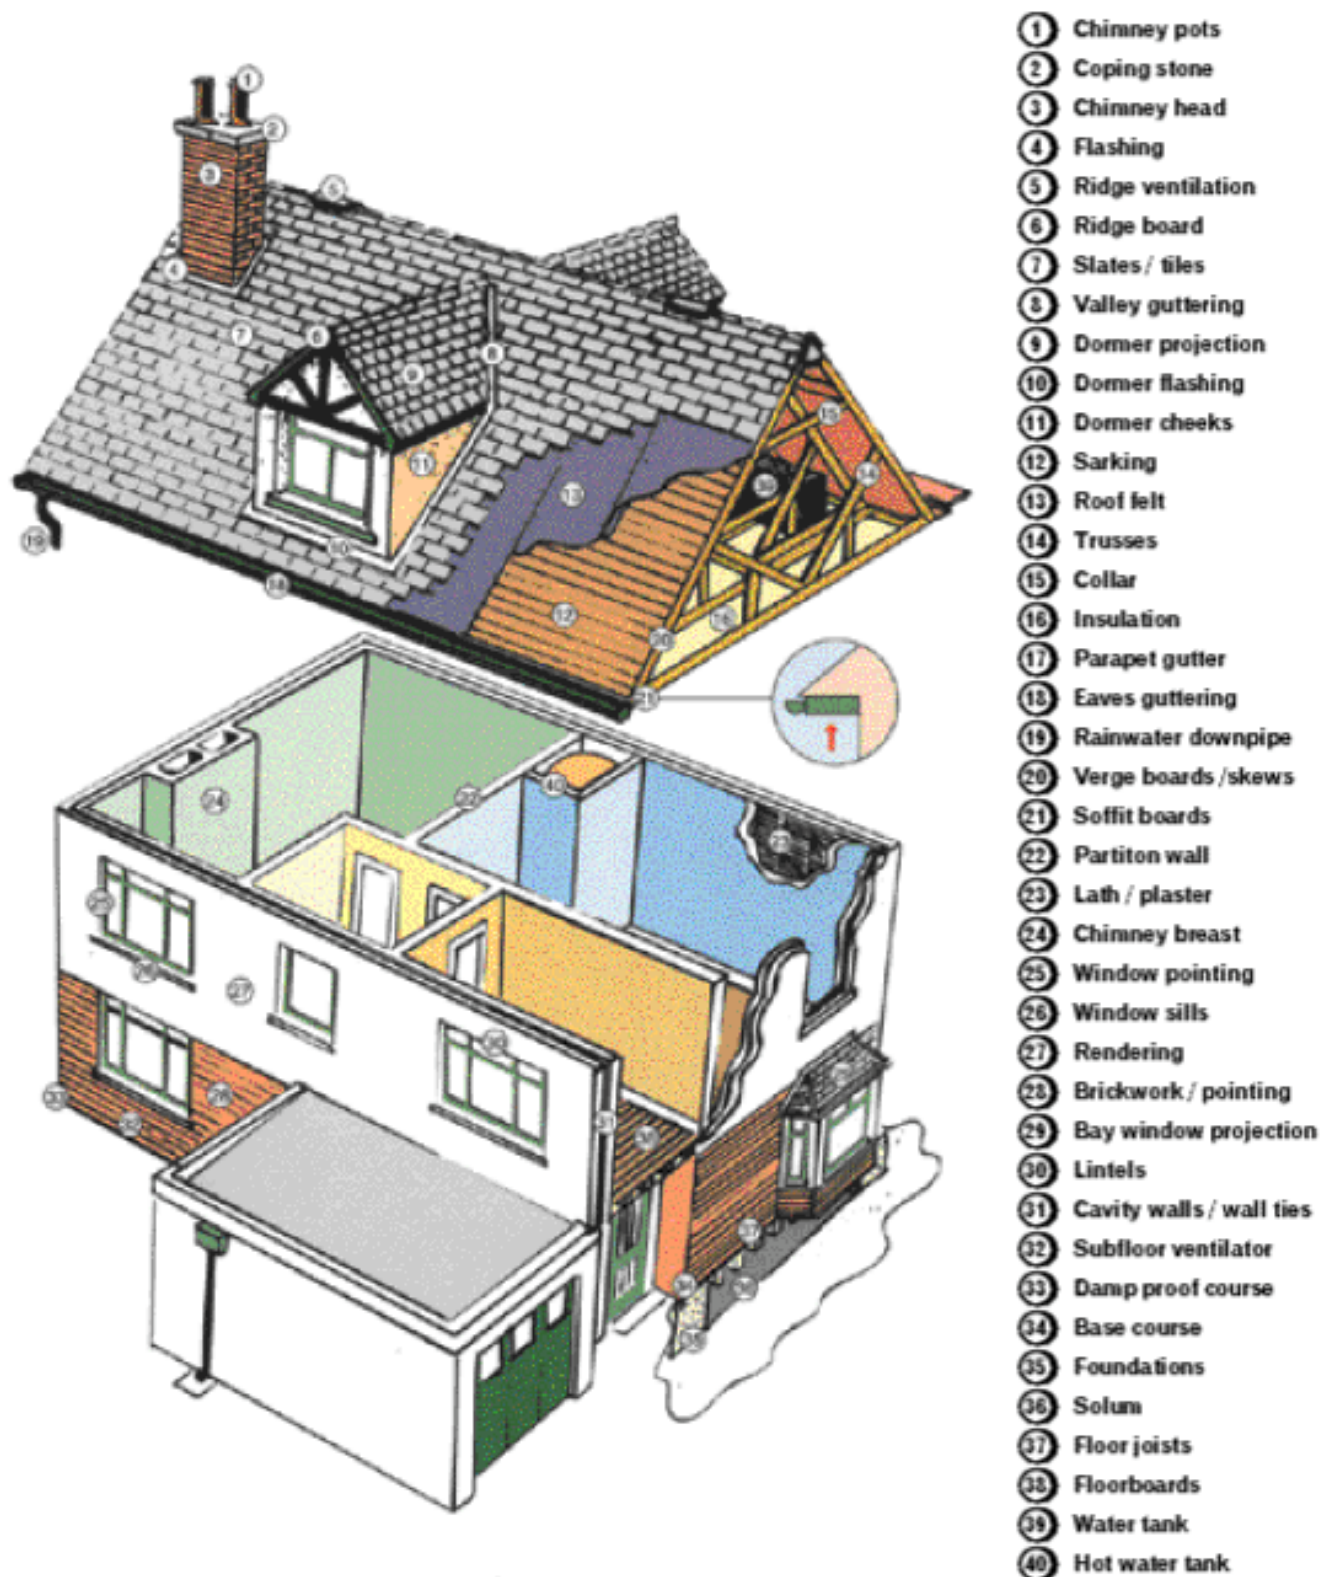
## Sectional diagram showing elements of a typical house

Reference may be made in this report to some or all of the above component parts of the property. This diagram may assist you in locating and understanding these terms.

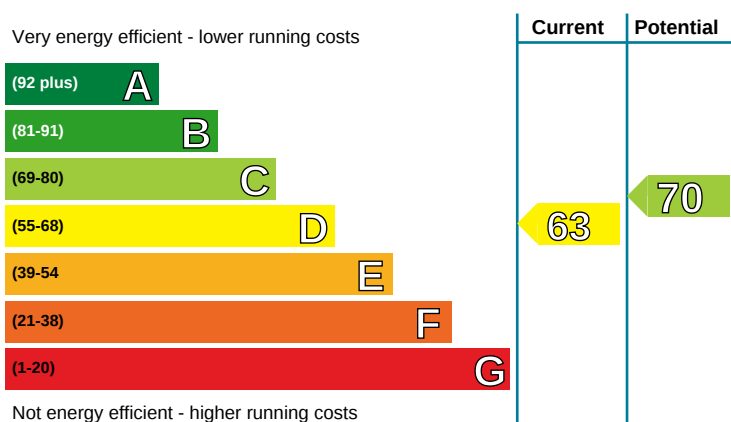
## Energy Efficiency Rating

This graph shows the current efficiency of your home, taking into account both energy efficiency and fuel costs. The higher this rating, the lower your fuel bills are likely to be.

Your current rating is **band D (63)**. The average rating for EPCs in Scotland is **band D (61)**.

The potential rating shows the effect of undertaking all of the improvement measures listed within your recommendations report.

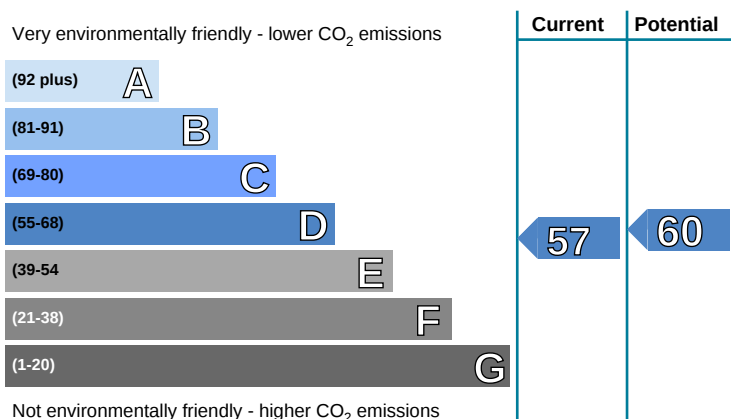
## Environmental Impact (CO<sub>2</sub>) Rating

This graph shows the effect of your home on the environment in terms of carbon dioxide (CO<sub>2</sub>) emissions. The higher the rating, the less impact it has on the environment.
