## Survey Report On

**Raviehall Cottage,  
Birsay,  
Orkney,  
KW17 2NA.**

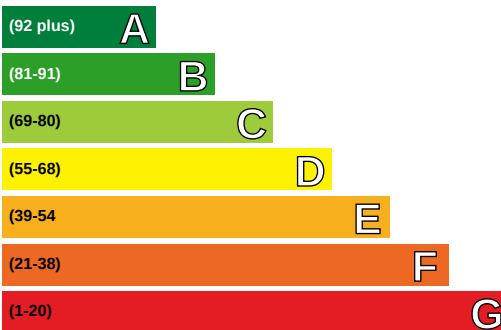
\* based upon the cost of energy for heating, hot water, lighting and ventilation, calculated using standard assumptions

Very energy efficient - lower running costs

| Current | Potential |
| 63 | 89 |

The potential rating shows the effect of undertaking all of the improvement measures listed within your recommendations report.

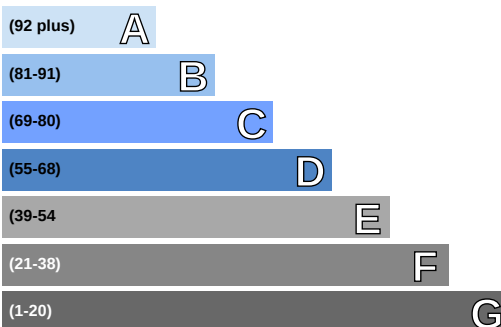
Very environmentally friendly - lower CO<sub>2</sub> emissions

| Current | Potential |
| 63 | 75 |
